| <div> <div>ES</div> <div> Title/Title: M100L ST, M8/12 R290, DHW, BT100TC-1/BT200TC-1,<br/>1 x mixing heating/cooling circuit, 1 x direct heating/cooling circuit<br/> Naziv: </div> </div> | Drawing ID/Zeichnungs ID/<br>Oznaka risbe: <b>Ver1</b><br>Revision/Prüfung/Revizija: MK |

| | Title/Title: MCB, M8/12 R290, DHW, BT100TC-1/BT200TC-1, 1 x mixing heating/cooling circuit, 1 x direct heating/cooling circuit | Drawing ID/Zeichnungs ID/ Oznaka risbe: <b>Ver1</b> |

| | Title/Titel: MCB, M15 R290, DHW, BT100TC-1/BT200TC-1, 1 x mixing heating/cooling circuit, 1 direct heating/cooling circuit | Drawing ID/Zeichnungs ID/ Oznaka risbe: <b>Ver1</b> |

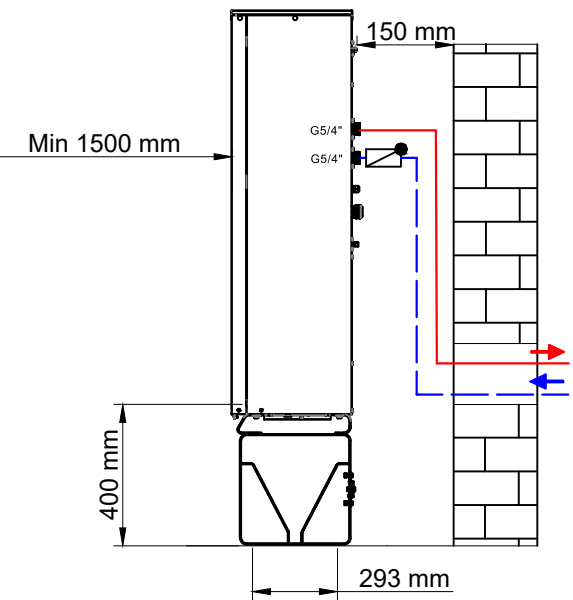
Site view ES M15 R290

ATTENTION!  
Check valve mandatory!  
Included in OU package
